## Sample Leak Prevention Report:

**May-02**  
**Leak in the Warehouse**  
**Date of Site Visit: May 10, 2004 @ 1100hrs**

**Roofco#: May-02**

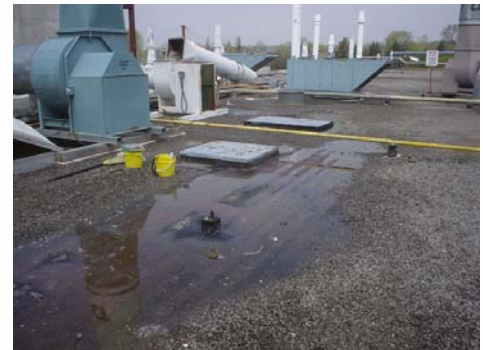
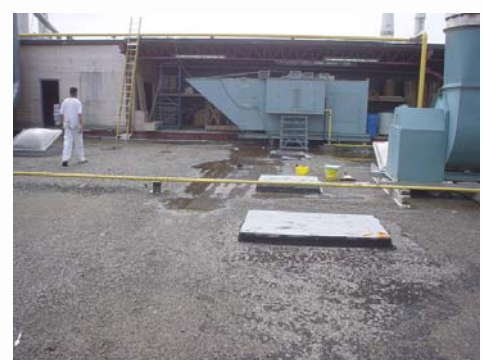
Following our investigation a 40ft by 20ft  
 section of collapsed roof was located.  
 This area was previously repaired by  
 others and has failed. In some section the  
 actual roof deck is exposed. A temp seal  
 was applied while onsite. Given the  
 current condition we feel that the temp  
 seal will not last more than 2-3 weeks.  
 Given the extent of the deterioration of the  
 existing membrane and insulation we fully  
 expect to find rust deck requiring anti-rust  
 treatments before the installation of a new  
 membrane and insulation.

1. Spot Replace Area of Deteriorated Membrane. Remove Redundant Curbs and Replace Deck.
2. Secure Counter Flashing as required and Caulked S-Locks in the area of the leak.

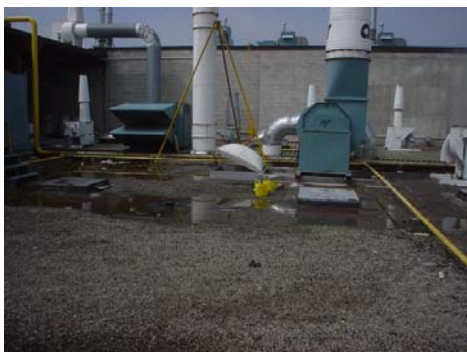
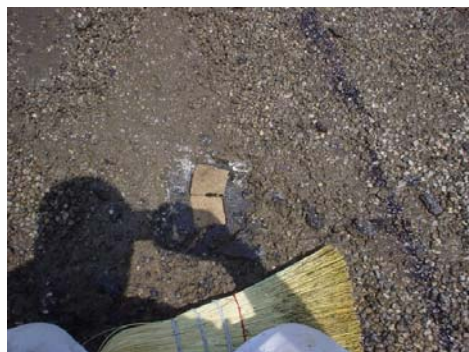
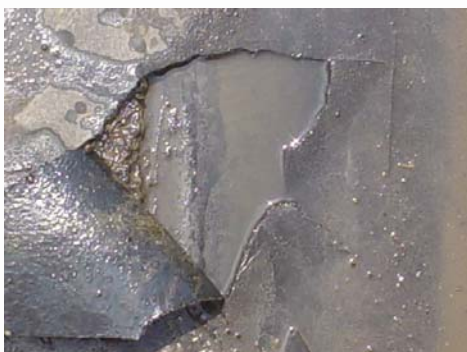
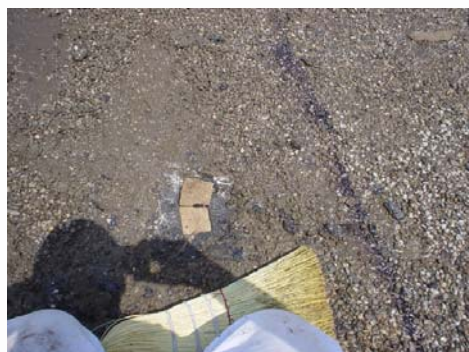
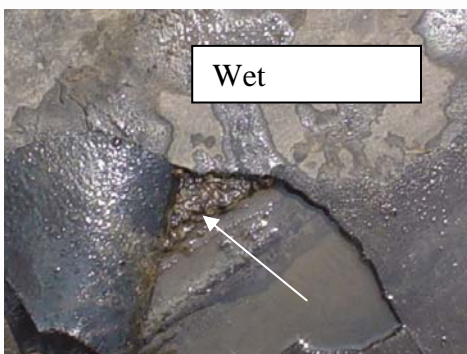
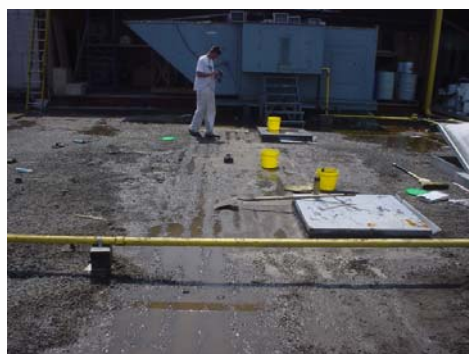
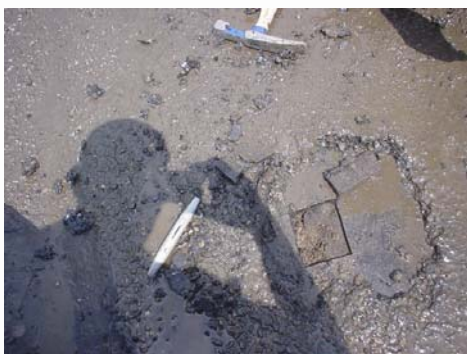
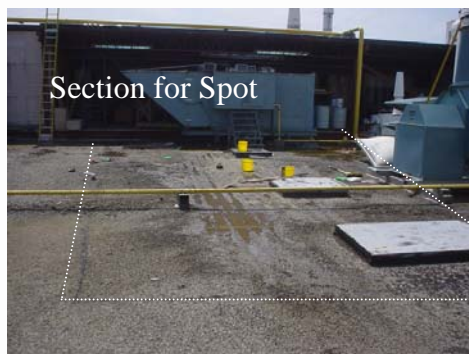
While on site, the electrician reported a  
 leak on the east side of Block A.  
 Following a brief investigation it was  
 discovered that the Flashings in this  
 section were holding water and  
 subsequently the water is entering the  
 building over the top of the metal.

Leaking at  
S-Lock
